A Study for the Improvement,  
Restoration, and Protection of

# Lake Bruce

Fulton and Pulaski Counties, Indiana

**A Study for the Improvement,  
Restoration, and Protection of  
Lake Bruce . . .  
Fulton and Pulaski Counties, Indiana**

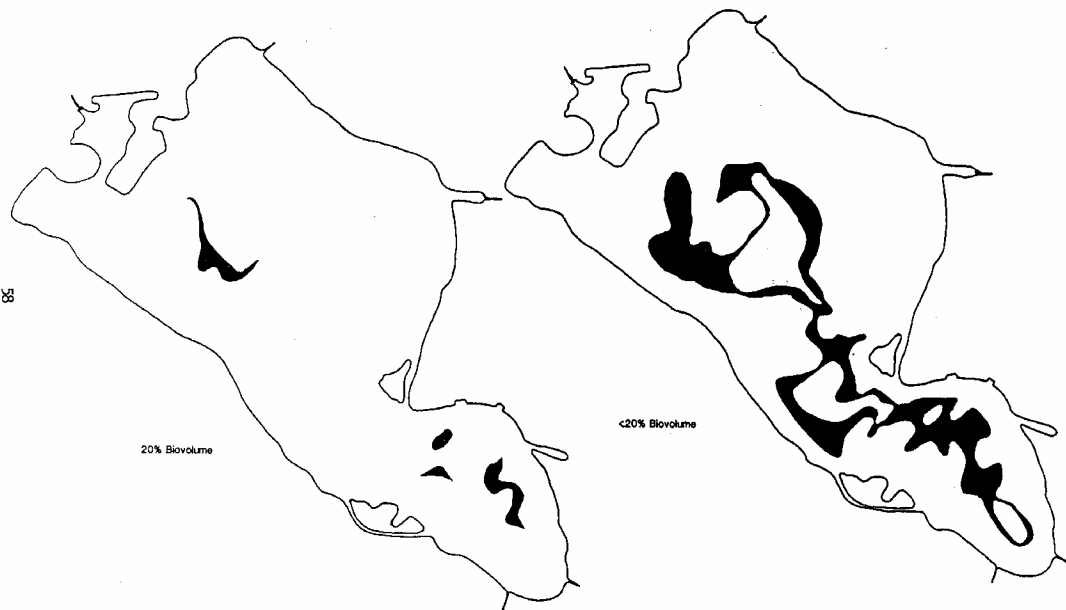
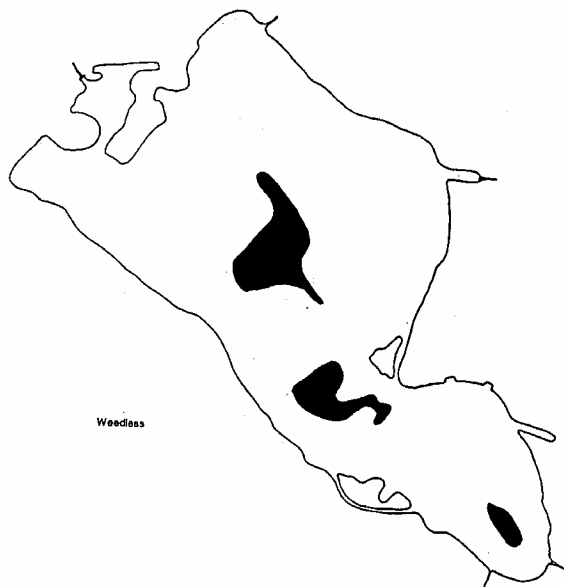
Figure 26. Plant Biovolume at Lake Bruce in Increments of 20% Water Column Infestation.

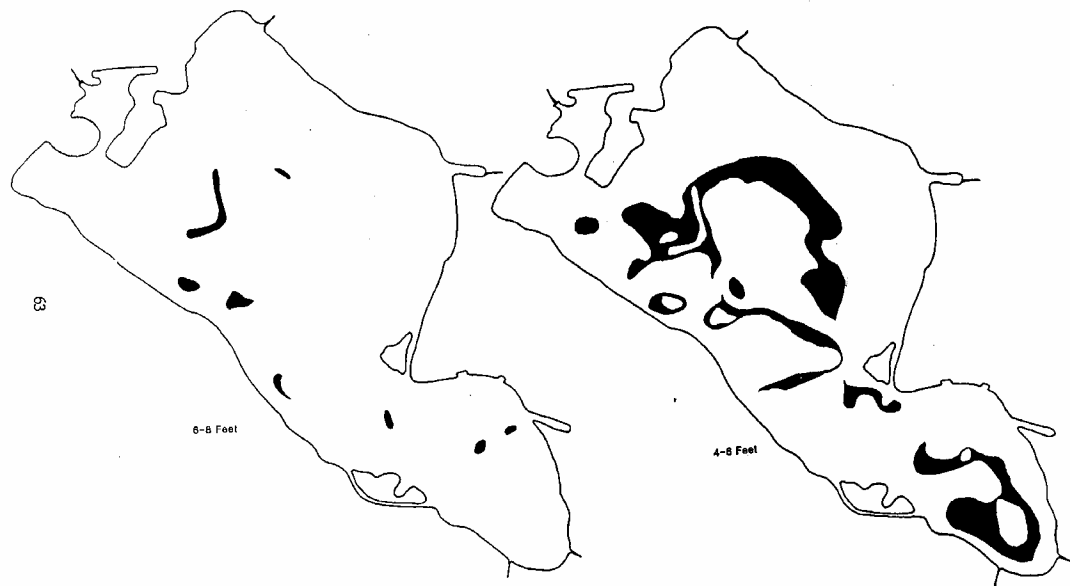
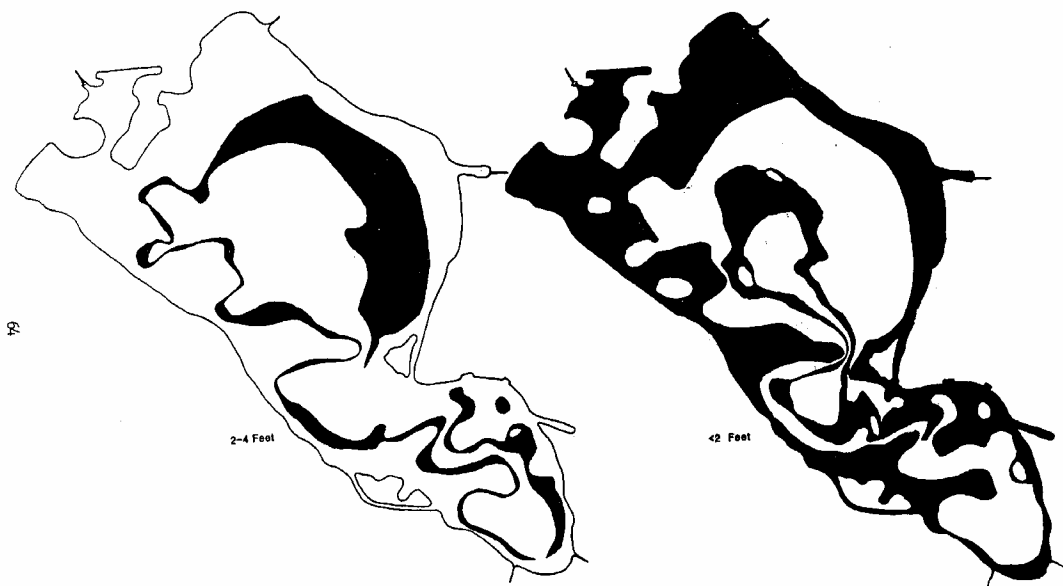
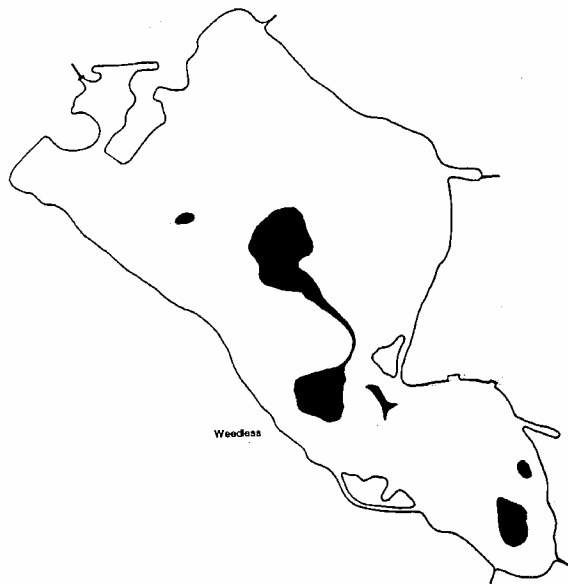
Figure 29. The Distribution of Aquatic Plant Height in Lake Bruce by 2 Foot Height Increments.

Actual plant heights for Lake Bruce are presented in Figure 28. For clarity, the distribution of individual 2-foot plant height increments have been presented in Figure 29. Plant heights 6-8 feet tall were recorded only in extremely small areas mostly in the north basin and are considered to have little bearing on the overall distribution of plant growth in the lake. Similarly, the north basin also had the greatest extent of plant growth 4-6 feet tall with maximum development along the eastern shore in water 5-10 feet deep.

Plant growth 2-4 feet tall reached maximum in the northern basin in water 5-10 feet. Plants less than 2 feet tall were found along the shore of both basins as well as in water greater than 10 feet deep. A majority of the weed problems along the shores of both basins are associated with such short vegetation that completely fills the water column of nearshore areas. As noted earlier, the deepest sections of both basins are completely weedless due to pronounced light limitation for plant growth.

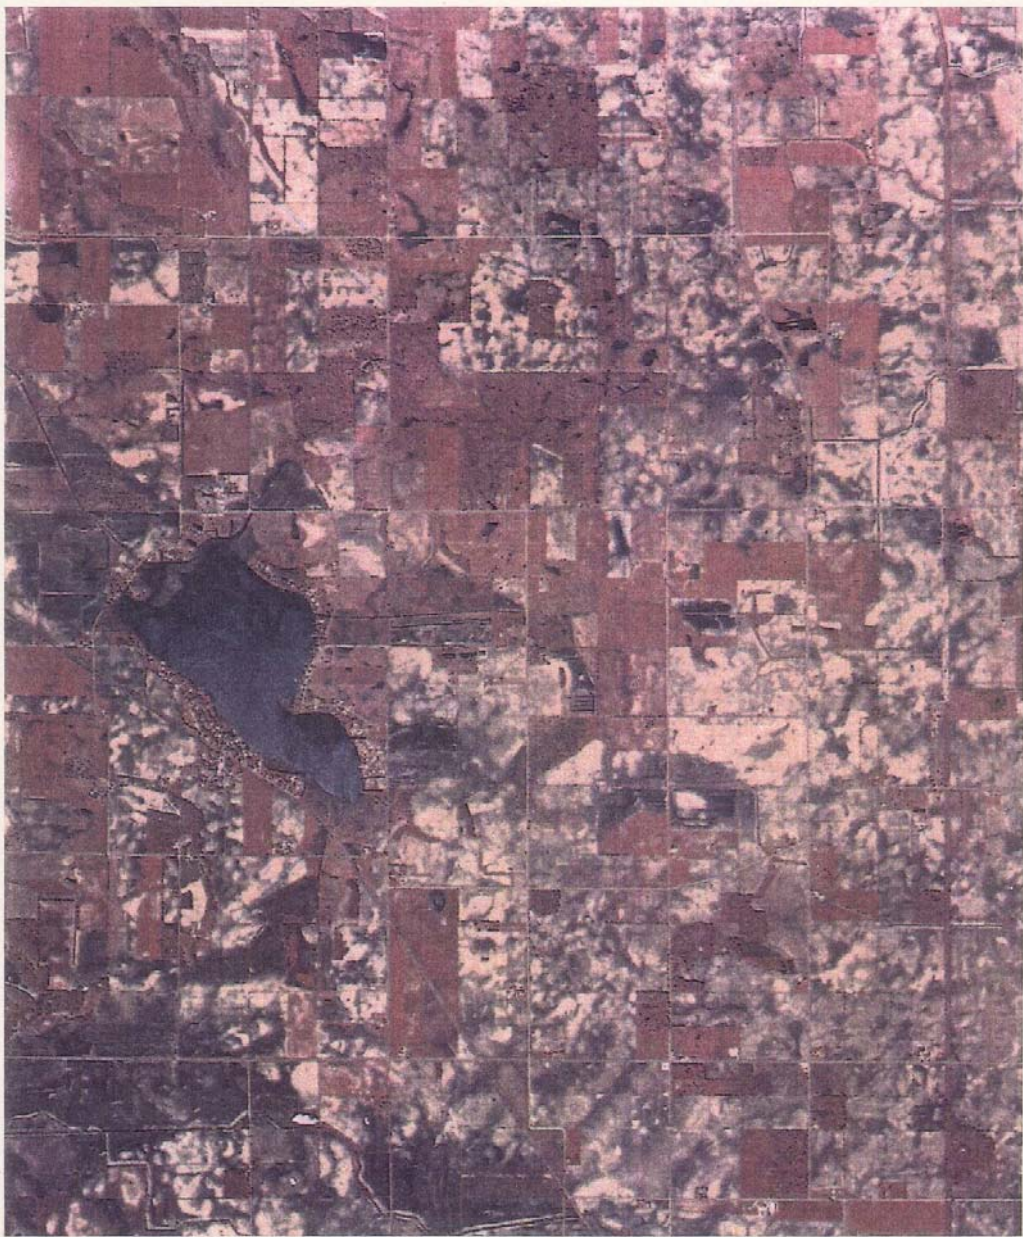
Figure 46. 1981, color infrared aerial photograph of the Lake Bruce watershed. Overlapping photos were viewed using a stereo scope to determine land use.
